**US Army Corps
of Engineers**

Technical Report HL-94-1
May 1995

Demonstration Erosion Control Project Monitoring Program

Fiscal Year 1993 Report

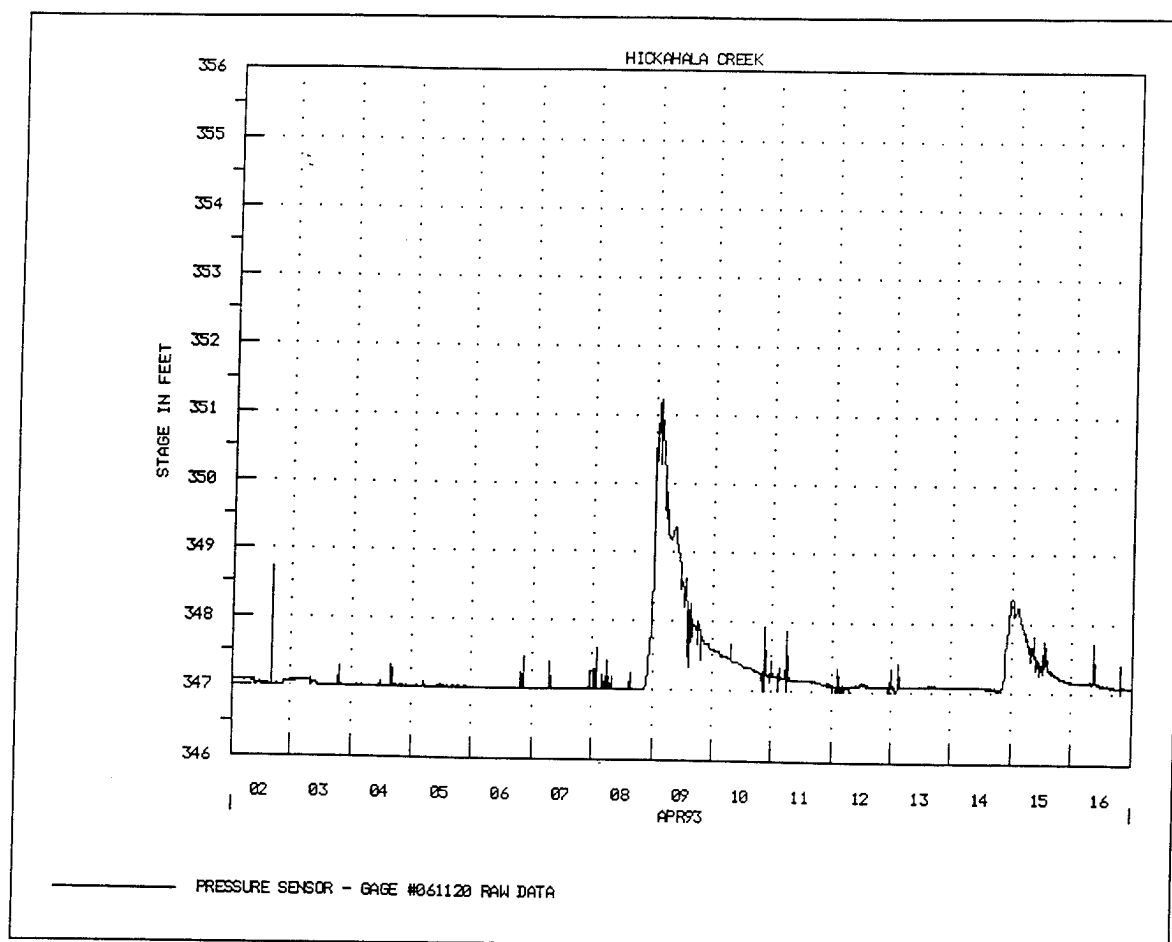
Figure 2. Pressure transducer data with spikes

When small amounts of data were initially graphed, many fluctuations due to temperature and large spikes of uncertain origin were noticed. For the Stevens transducers the spikes were generally not more than 1 to 1-1/2 ft,¹ while for the ultrasonic sensors, they varied from 0.5 ft to the instrument's maximum range. The cause for the anomalous readings from the pressure transducers has not been ascertained. The causes for the anomalous readings from the ultrasonic instruments have been found to be due to any of various circumstances, some of which are no water in the creek, insect nests in the wave guide, birds flying under the instrument, and damaged or malfunctioning pulse emitters. An example of data from a pressure transducer assembly that produced unwanted and unidentified spikes is shown in Figure 2. Data from an ultrasonic data collection assembly that includes various spikes and spurious data are shown in Figure 3.

It can be seen by viewing the raw data shown in Figures 2 and 3 that, in general, the desired hydrographs of 1-ft rise and larger can be visually picked out. However, the "noise" can be distracting and also takes up much data storage space. For most purposes in the DEC monitoring project, events of less than 1 ft are not of significant interest. Therefore a spike-removal/data-averaging program was written that uses these raw data files to produce files that are much clearer and smaller. The program works by checking for changes in stage values greater than some amount that is observed to be possible in the data logging interval (10 min). The greatest observed change in stage over 10 min that was found was approximately 1.2 ft. Therefore a conservative value of 1.5 ft was selected. Thus, whenever a change in stage of more than 1.5 ft in a 10-min interval occurs, the program considers it a spike, and deletes it from the data. The inherent danger in this is that a real change greater than 1.5 ft in the interval could possibly happen. However, then a hydrograph with a missing peak would be evident. The raw data files are saved, and thus the data could be retrieved and the peak reconstructed manually.

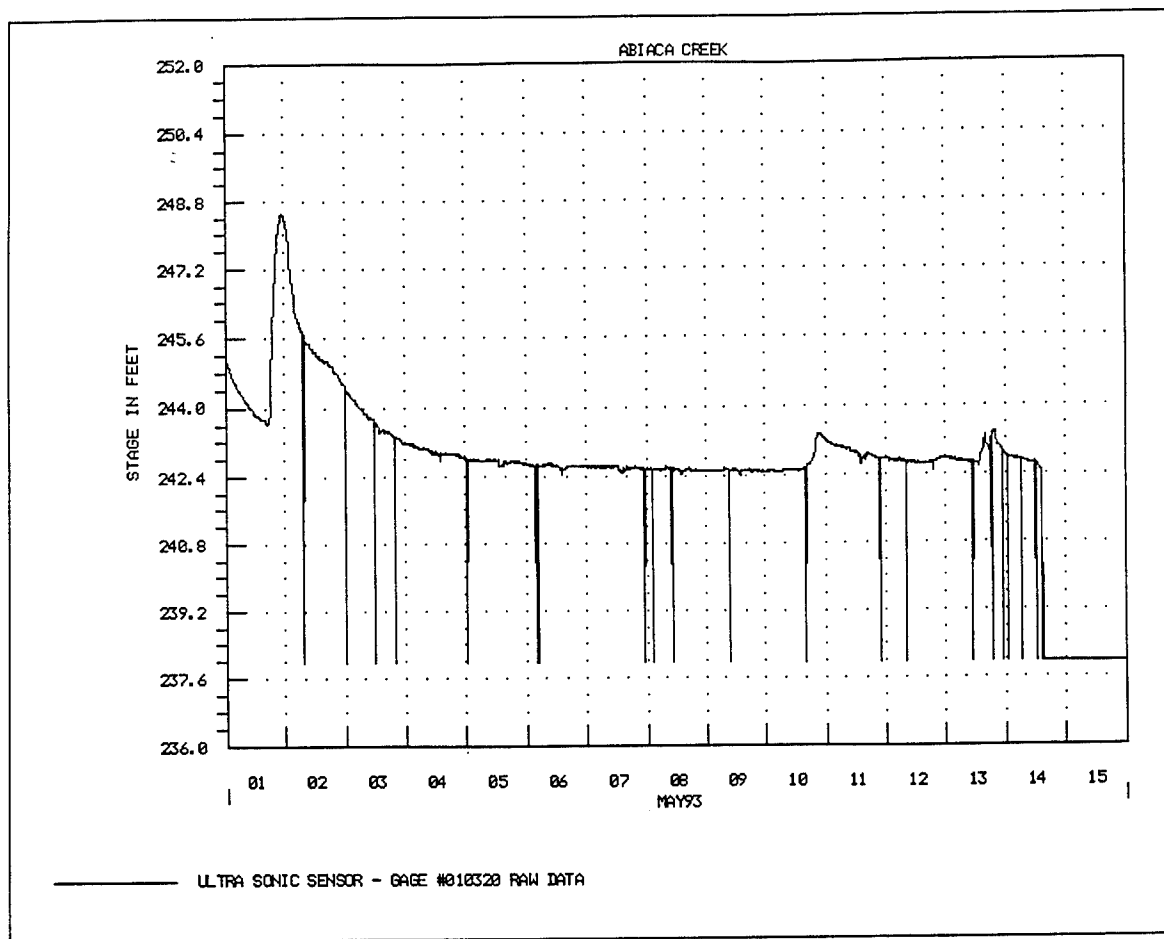
Figure 3. Ultrasonic sensor data with spikes

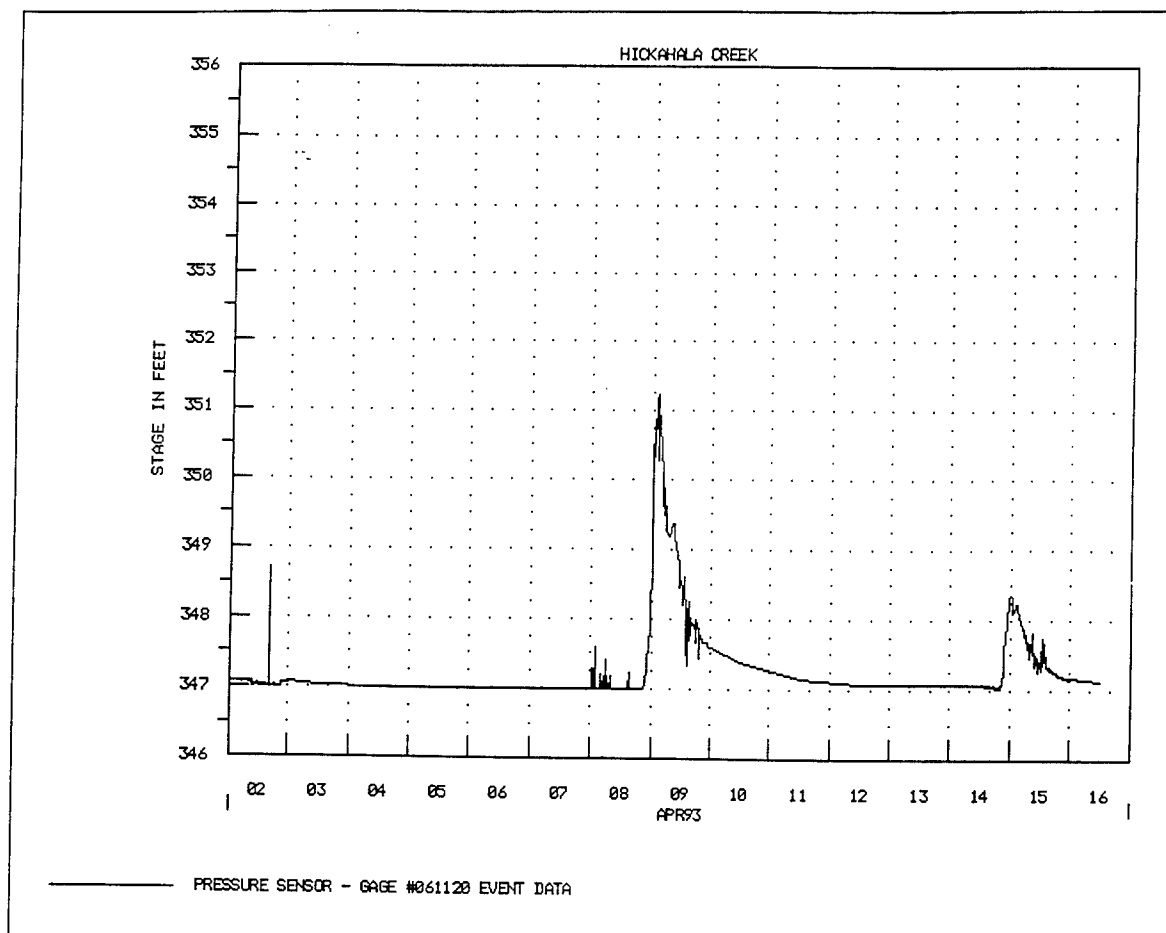
Figure 4. Reduced pressure transducer data

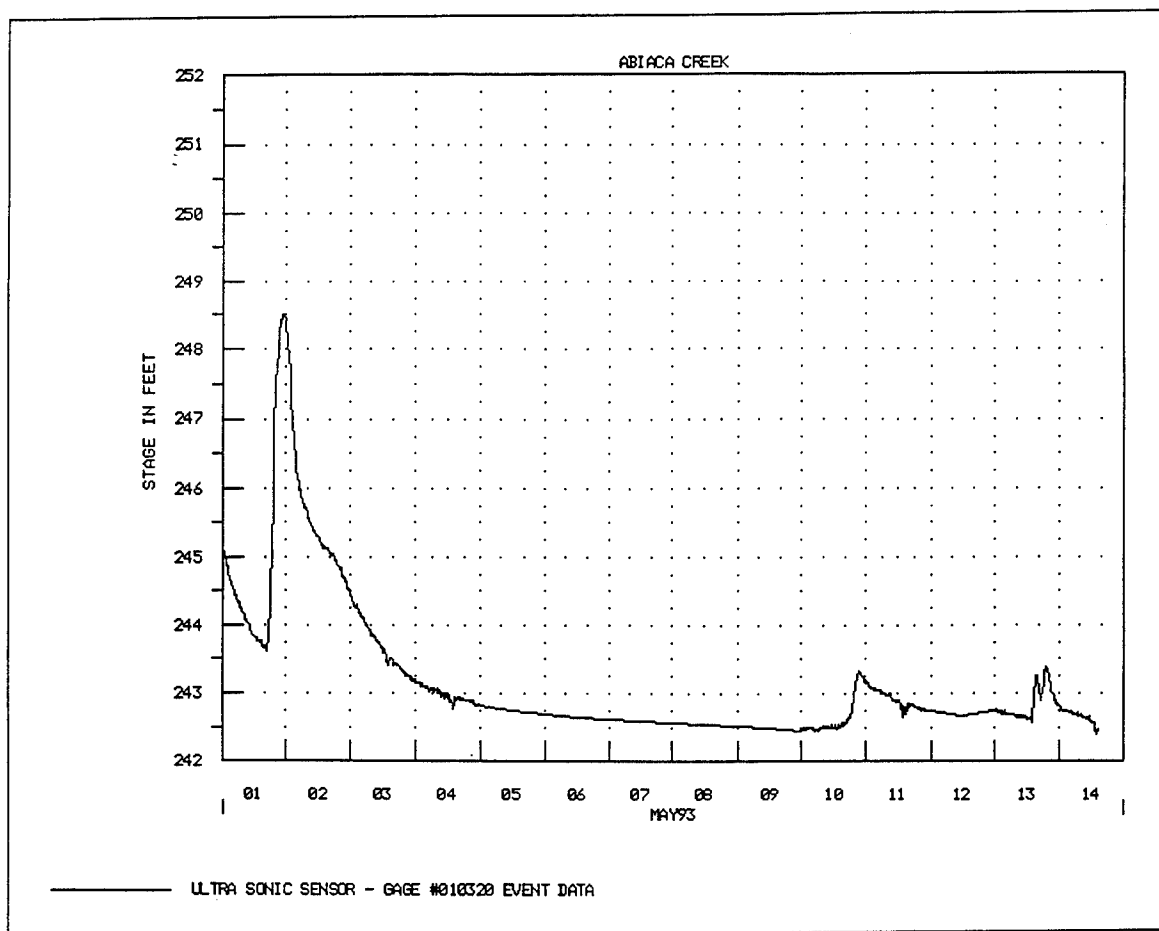
Figure 5. Reduced ultrasonic sensor data

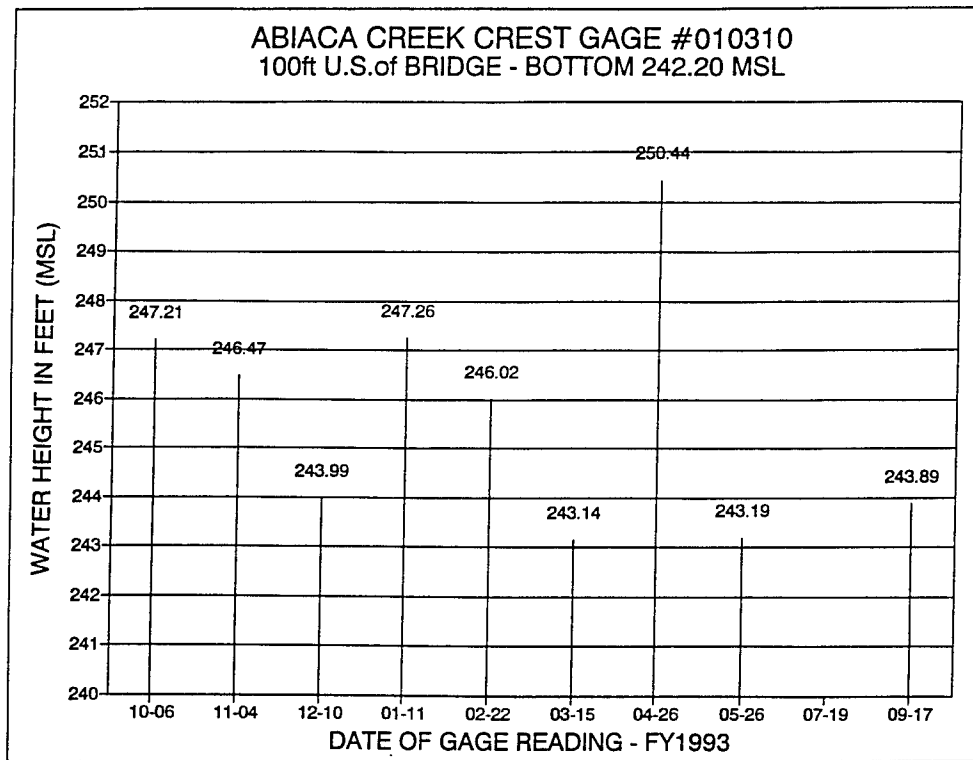
Figure 6. Example crest gauge readings

The final check for the data was assessing the accuracy. In terms of absolute accuracy, a test is planned for the ultrasonic instruments and pressure transducers in early FY 94. This assessment is envisioned to involve a statistical analysis of recorded, averaged, and measured data from a single field site over a 48-hr period. In the absence of such data, and based on cursory field observations, the ultrasonic data can show a range of variation of ± 0.15 ft. This appears to be due largely to temperature variations and wind. Other than the assessment of this elusive absolute accuracy, the instruments were checked for relative accuracy, i.e., transducer variation. That is, they were compared one against the other for duplication of event magnitudes and times. Also, where possible, they were compared to crest gauges. The crest gauge readings and the date on which each one was read are shown in graphs like those of Figure 6.

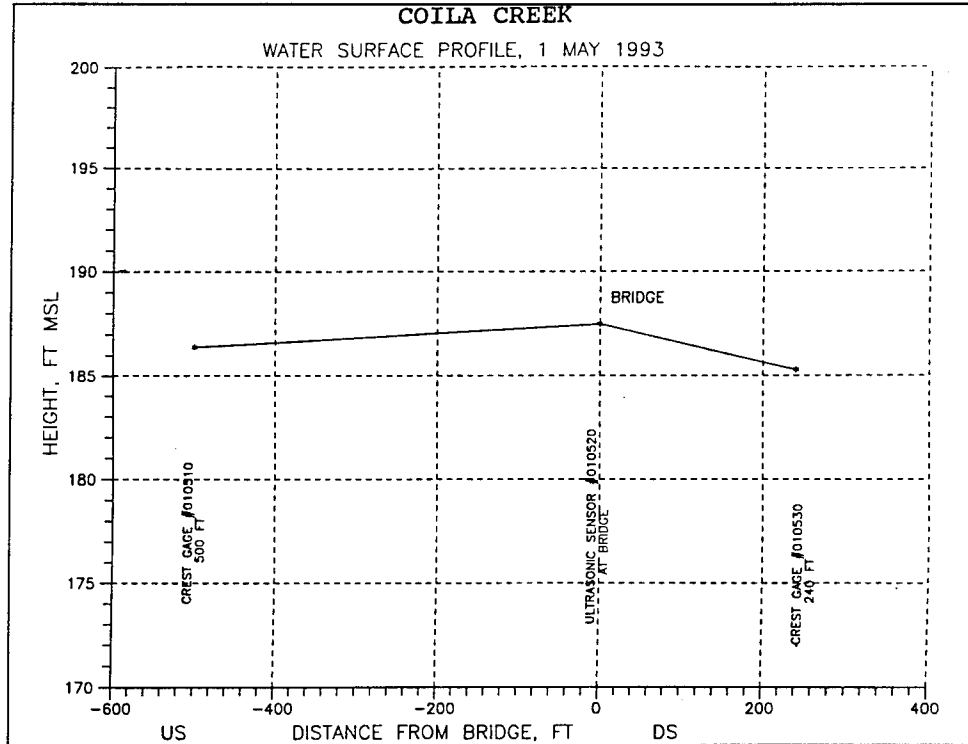
Figure 7. Example water surface profile

Finally, several of the larger events for each site were graphed as a profile. One of these graphs can be seen in Figure 7. This figure is intended not just to show the profile, but also to help the viewer visualize the location and identification number of each instrument at the site.

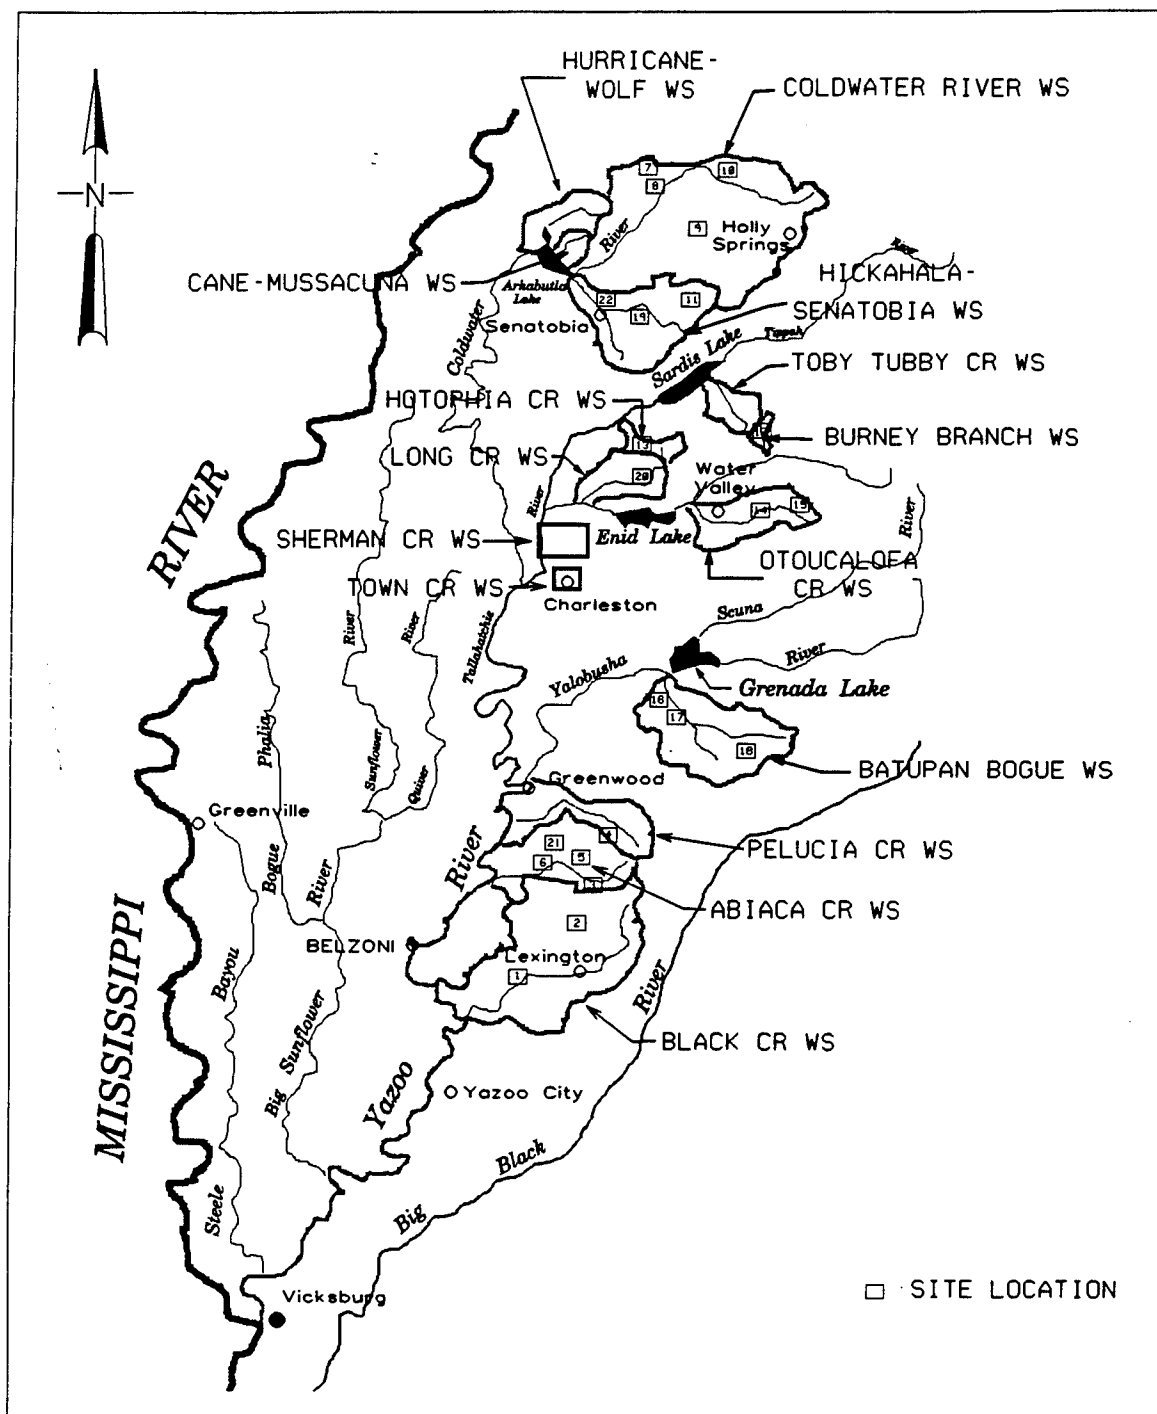
Figure 9. Site location map

The selected sites include approximately 15 existing low-drop structures, 3 existing high-drop structures, an anticipated channelization project, 20 anticipated low-drop sites, 2 anticipated high-drop sites, chevron dikes, bank stabilization, a sediment basin, and 6 control reaches in approximately 32 miles of study reach at 22 different locations. These sites have been selected to represent many of the different DEC watersheds, types of channel planform and sediment gradation, particular causes of instability, types of channel rehabilitation, and locations of special interest. The location of the 22 monitoring sites for 1993 are shown in Figure 9. Each site will be briefly discussed in the following sections.

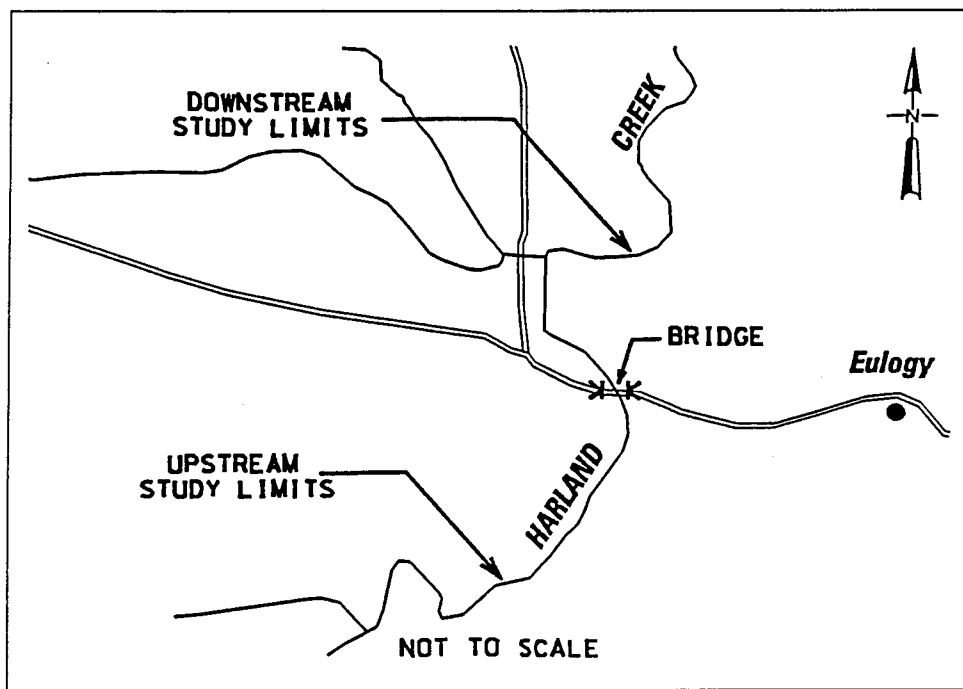
Figure 10. Harland Creek, Site 1

Site 1 is located on Harland Creek in the Black Creek watershed. The site is near Eulogy, MS, and can be found on the Lexington quadrangle map in T14N, R1E, Sections 22 and 27. Harland Creek is a mixed sand and gravel bed stream, exhibiting some of the original meandering tendency shown on the map in Figure 10. The study reach is approximately 4,000 ft in length, 2,000 ft upstream and downstream of the county road bridge. The stream is unstable, with bank erosion and significant channel widening. Several areas of massive bank failures were identified, and these failure sites, along with bed and bank erosion, provide a high sediment yield to the downstream.

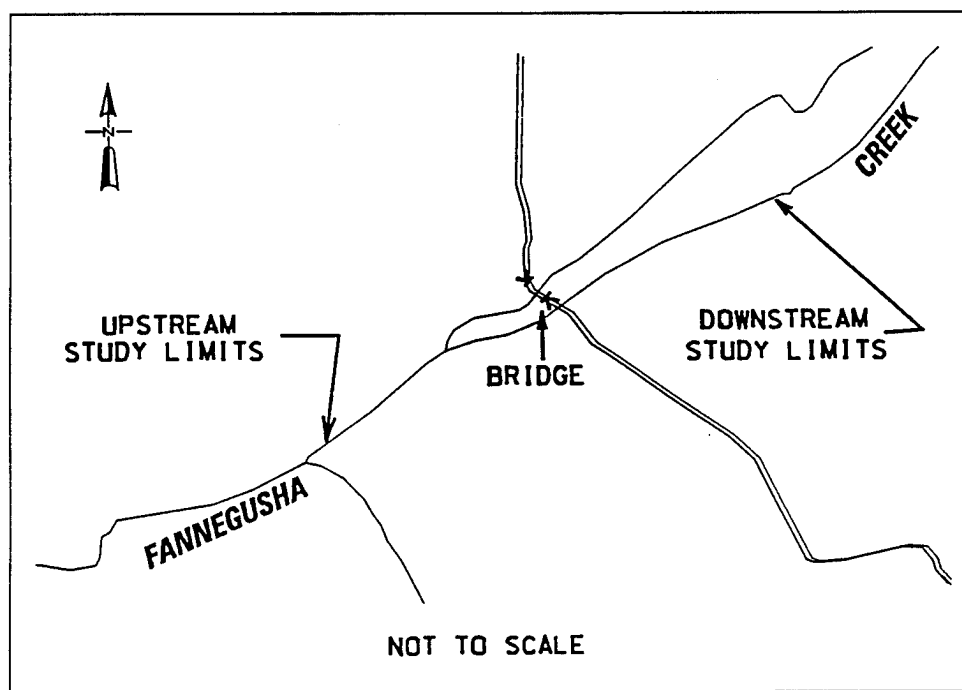
Figure 11. Fannegusha Creek, Site 2

Site 2 is located on Fannegusha Creek, also in the Black Creek watershed, and can be found on the Coila quadrangle map in T16N, R3E, Sections 1 and 2. As shown in Figure 11, the study reach is approximately 4,000 ft in length, 2,000 ft upstream and downstream of a county road bridge. Two low-drop structures are planned for the site, one immediately downstream of the bridge and the other approximately 2,000 ft downstream of the bridge. The stream is presently unstable, and it has been reported that the county bridge has been closed since January 1992 due to channel widening. Initial

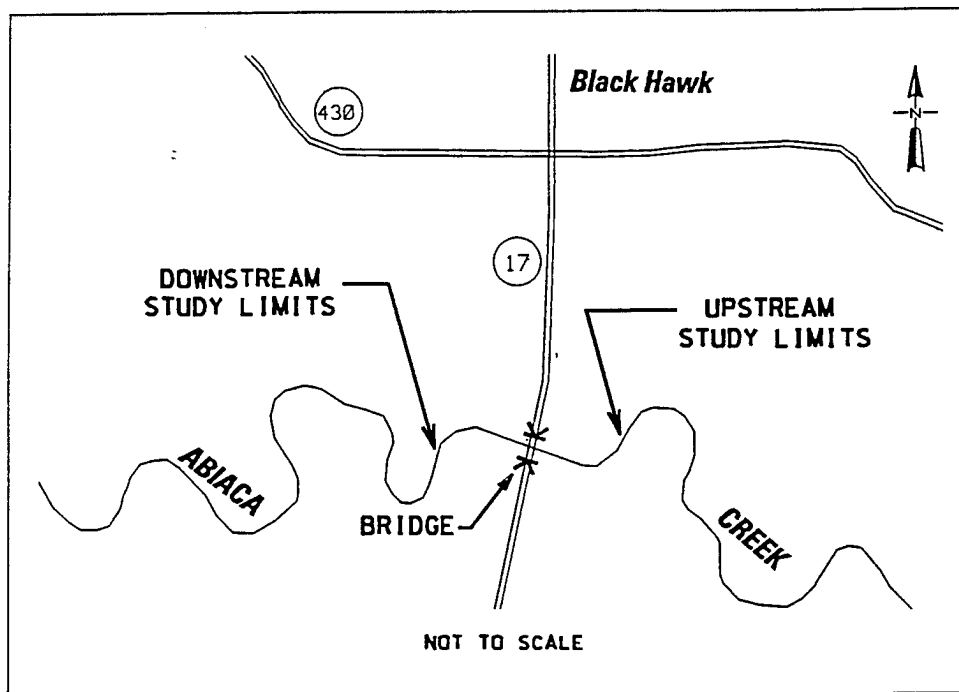
Figure 12. Abiaca Creek, Site 3

Site 3 is shown in Figure 12, and is located in T17N, R3E, Section 20, at the Highway 17 crossing of Abiaca Creek. The approximate watershed area at this site is 26.5 square miles. This site was selected because of the relative stability of the channel at this location, particularly in comparison with the downstream sites that have been severely impacted by gravel mining. The streambed at Site 3 is primarily a sand bed with minor amounts of gravel, and the banks are generally well vegetated with mature vegetation down to the low-water surface. However, erosion of the outside bank of the bendways was noted.

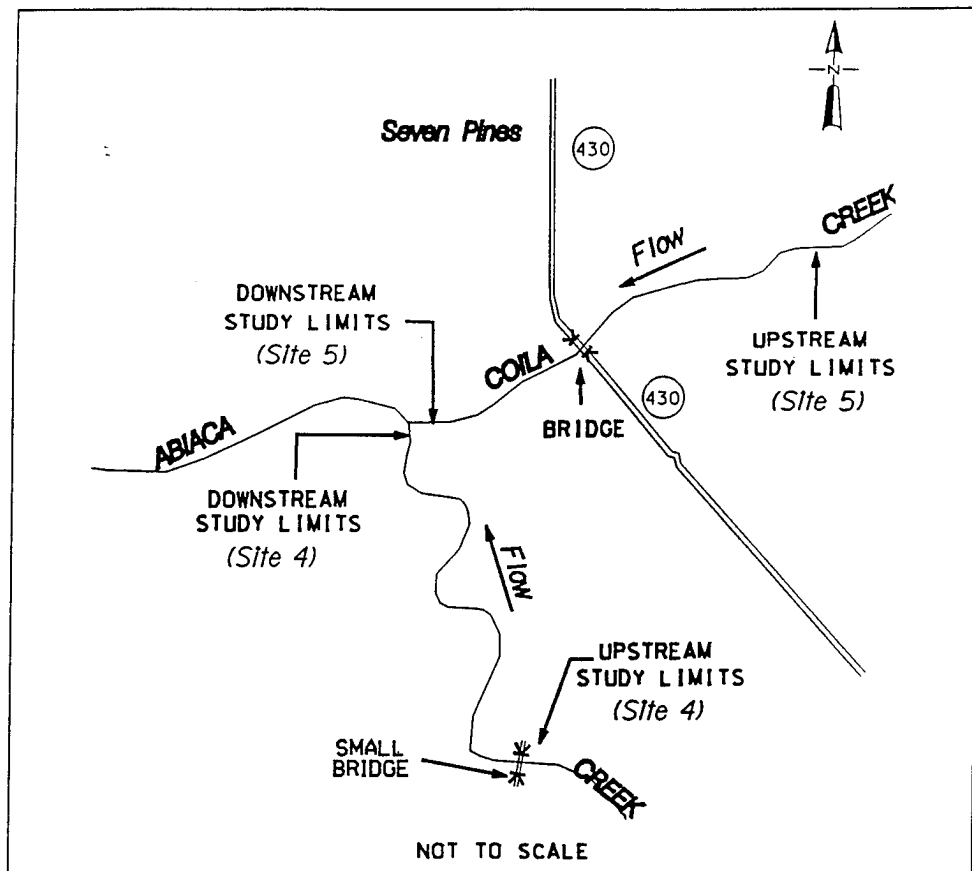
Figure 13. Abiaca Creek, Site 4, and Coila Creek, Site 5

Site 4 is on Abiaca Creek and extends approximately 4,000 ft upstream from the confluence of Coila Creek as shown in Figure 13. This site is located in T17N, R2E, Section 4, and has a watershed area of approximately 44 square miles. This site is also located approximately 1.8 miles downstream of a major sand and gravel processing operation that can be associated with increased supply of suspended and bed material load. Stream banks in this reach are relatively stable, and the bed gives the appearance of an aggraded reach.

Site 5 is located on Coila Creek, a tributary to Abiaca Creek in T17N, R2E, Section 4. The site extends upstream approximately 4,000 ft from the confluence with Abiaca Creek as shown in Figure 13. The site has a watershed area of approximately 42 square miles, very similar to Site 4, and allows

Coila Creek Site 5 extends upstream from the confluence with Abiaca Creek for a distance of approximately 4,000 ft. The study reach extends approximately 2,000 ft upstream of highway bridge 430, as shown in Figure 13. The approximately 42.1-square-mile watershed upstream of the reach had been heavily mined previously, and a high proportion of the present watershed is controlled by SCS reservoirs. Figure 36 is a comparison of the 1992 and 1993 thalweg profiles for Coila Creek. The surveyed thalweg slope for 1992 was 0.0018 and was 0.0019 in 1993. Only minor change is evident in comparison of thalwegs, with minor degradation along the channel from 1992 to 1993.

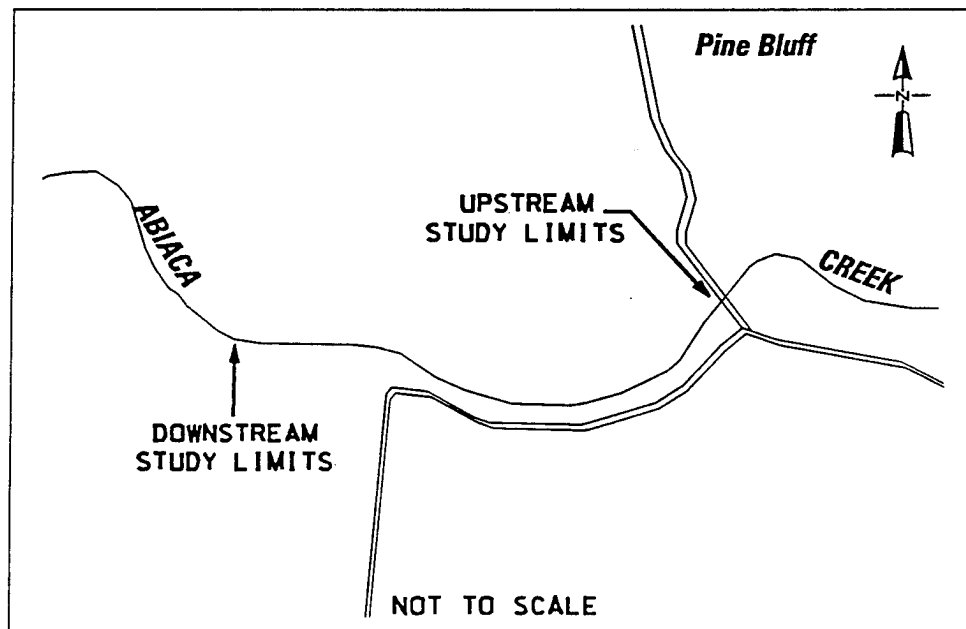
Figure 14. Abiaca Creek, Site 6

Site 6 is located on Abiaca Creek as the stream emerges from the hill line into the flatter Yazoo Delta in T17N, R1E, Sections 13 and 14, as shown in Figure 14. Drainage area at this location is approximately 99 square miles. This is the site of the Pine Bluff gauging station with records from 1963 to 1980. This station has recently been reactivated and includes a pumped sediment sampler. The study reach extends approximately 4,000 ft downstream of the Pine Bluff gauging station.

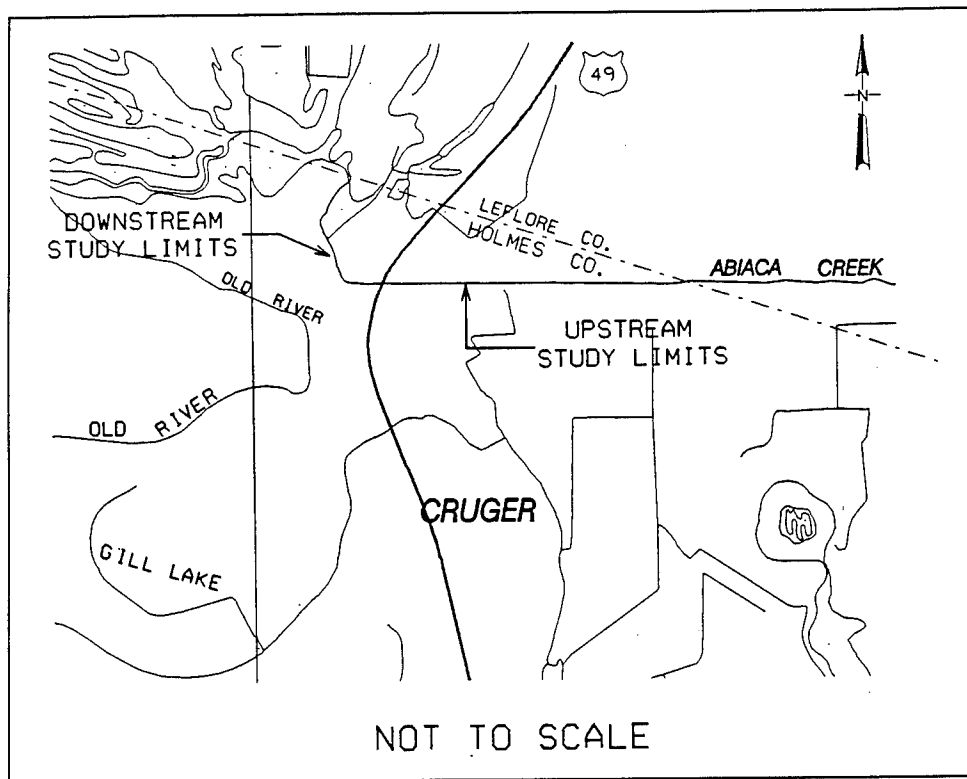
Figure 15. Abiaca Creek, Site 21

Site 21 is in T17N, R1E, Section 18, near the mouth of Abiaca Creek at Highway 49 as the stream enters the wildlife area (Figure 15). The Vicksburg District has designed a sediment trap basin at this location by setting the levees back and allowing frequent overflow of the stream. The reach is approximately 4,000 ft in length.

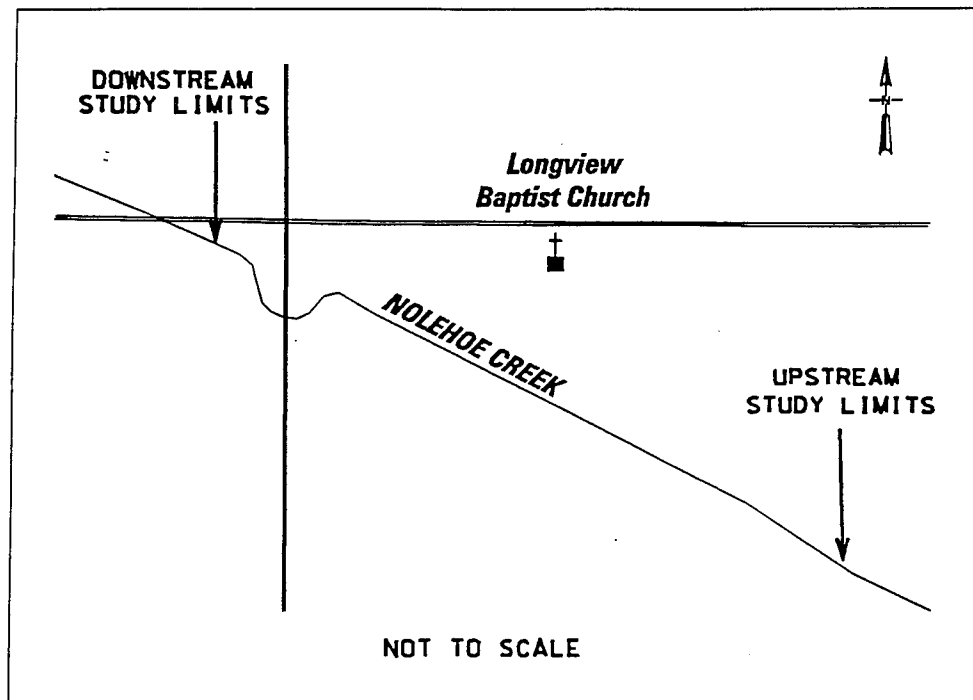
Figure 16. Nolehoe Creek, Site 7

Site 7 is located on Nolehoe Creek in the Coldwater River basin near the community of Olive Branch, MS. The site is located on the Hernando quad-range map, T1S, R7W, Section 35, and has a drainage area of approximately 3.7 square miles. The study reach, shown in Figure 16, is approximately 4,000 ft in length, extending downstream from a box culvert. The channel is extremely unstable and is deeply incised. Bed material load ranges from sand to particles in excess of 30 mm. Two low-drop structures are planned for the reach; however, permission to construct the structures has not been received from the landowner. Stream stage recording stations have been recently installed by WES at the downstream roadway culvert.

This incising reach is between upstream and downstream box culverts, and the reach is representative of suburban development in the metro-Memphis area. An interview with a local landowner confirmed that a major cutoff of the channel had been made in the last 10 years. These conditions are typical of the result of ill-planned local development improvements, and the documentation of the resulting problems may be of value in assisting future local drainage planning.

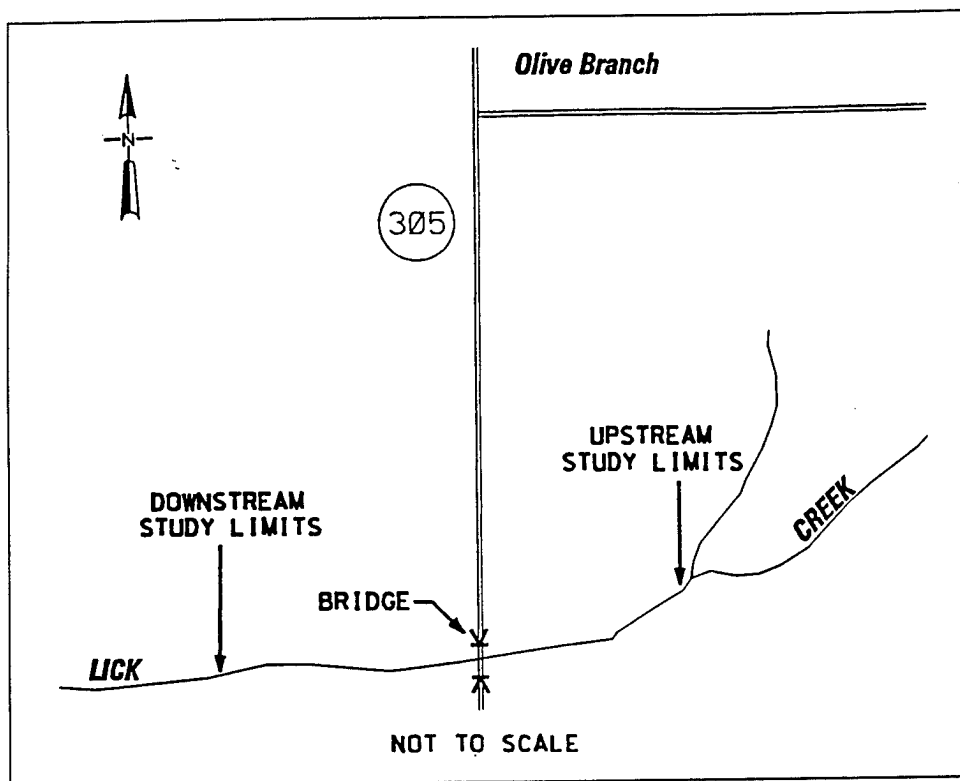
Figure 17. Lick Creek, Site 8

Site 8 is on Lick Creek in the Coldwater River basin, approximately 2 miles south of Olive Branch, MS, at the site of an anticipated high-drop structure, which is planned to protect the Highway 305 bridge. Shown in Figure 17, the study reach is approximately 4,000 ft in length, 2,000 ft upstream and downstream of the bridge, in T2S, R6W, Section 3. This site is also on the Hernando quadrangle map. Watershed area is approximately 8.5 square miles. Stream gauging is planned for the future at this site; however, no stream gauging is presently available.

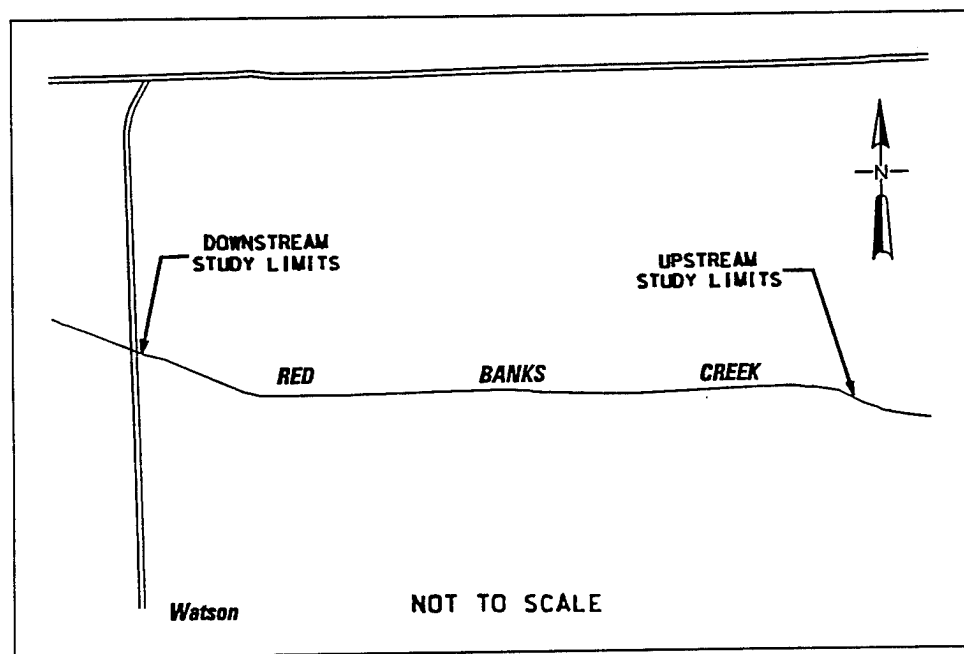
Figure 18. Red Banks Creek, Site 9

Site 9 is located on Red Banks Creek in the Coldwater River basin. As shown in Figure 18, the study reach extends approximately 2.5 miles upstream from the bridge on the county road between the communities of Warsaw and Watson, MS. This site can be located on the Byhalia quadrangle map, T3S, R5W, Section 24, and R4W, Sections 19 and 20, and has a

watershed area of approximately 28 square miles. The bed sediment load is sand, and the stream flows in a deeply incised and widened, straight channel resulting from earlier channelization. Site 9 is unique in that it is the only DEC monitoring site using chevron dikes and longitudinal dikes for channel stabilization.

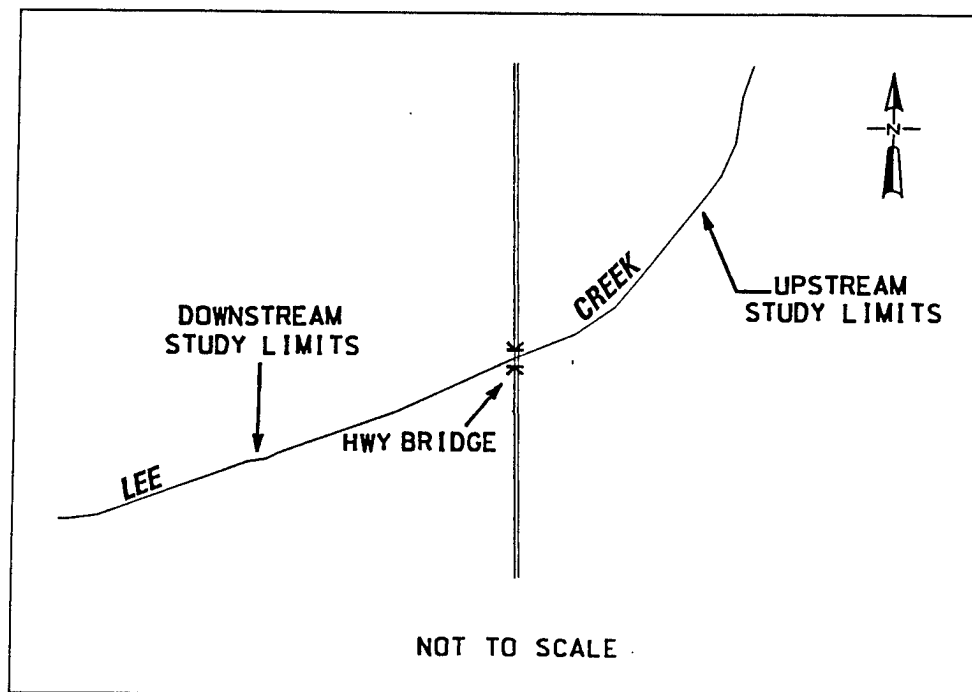
Figure 19. Lee Creek, Site 10

Site 10 is on Lee Creek in the Coldwater River basin, approximately 6 miles north of Victoria, MS. The site can be located on the Byhalia quadrangle map in T2S, R4W, Sections 9 and 10. As shown in Figure 19, the study reach extends approximately 2,000 ft upstream and downstream of the highway bridge. The channel is relatively stable and is transporting minor amounts of gravel in a sand bed. Upstream of the bridge, the channel exhibits some meandering and apparently has not been channelized in this reach. Downstream of the bridge, the channel is stable with mature, 14-in.-diameter trees near the low-water surface. The remnants of spoil piles indicate that the lower channel has been channelized. This reach provides an excellent opportunity to document a stable, channelized, sand bed stream.

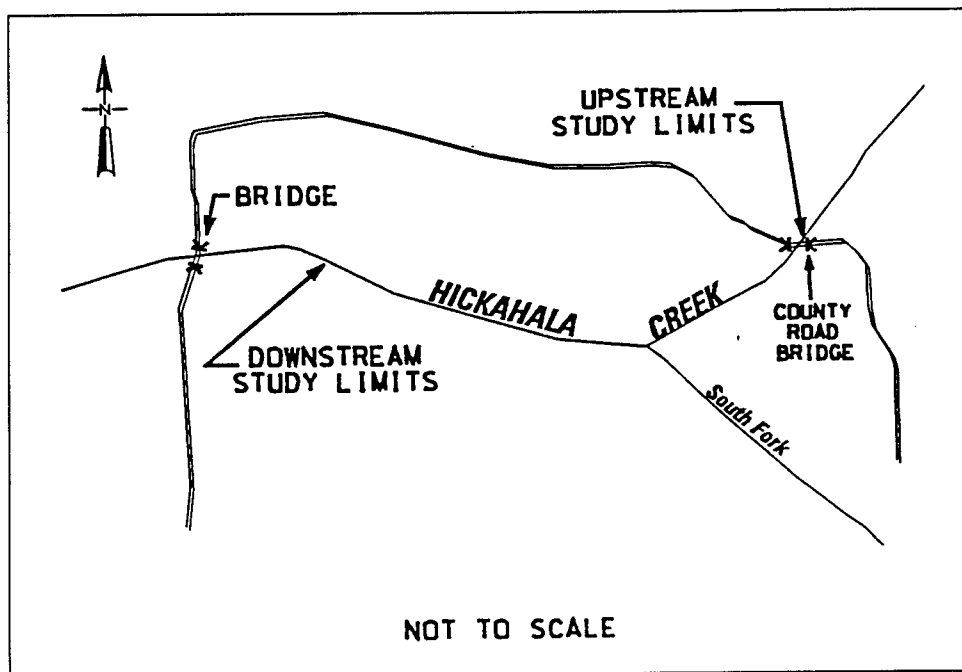
Figure 20. Hickahala Creek, Site 11

Site 11 is located in the upper watershed of Hickahala Creek, a watershed area of approximately 9 square miles. The site is located on the Tyro quadrangle map in T5S, R5W, Sections 2 and 3, a portion of which is shown in Figure 20. The site begins at a county road bridge and extends downstream to the confluence with the South Fork, and continues downstream on Hickahala Creek for approximately 1.25 miles. The total study reach is approximately 2 miles in length and includes three existing structures. The lower portion of the study reach is actively incising into a clay, cohesive bed. The upstream portion of the study reach is relatively stable with a sand bed. The reach was selected to monitor the response of the complex of structures.

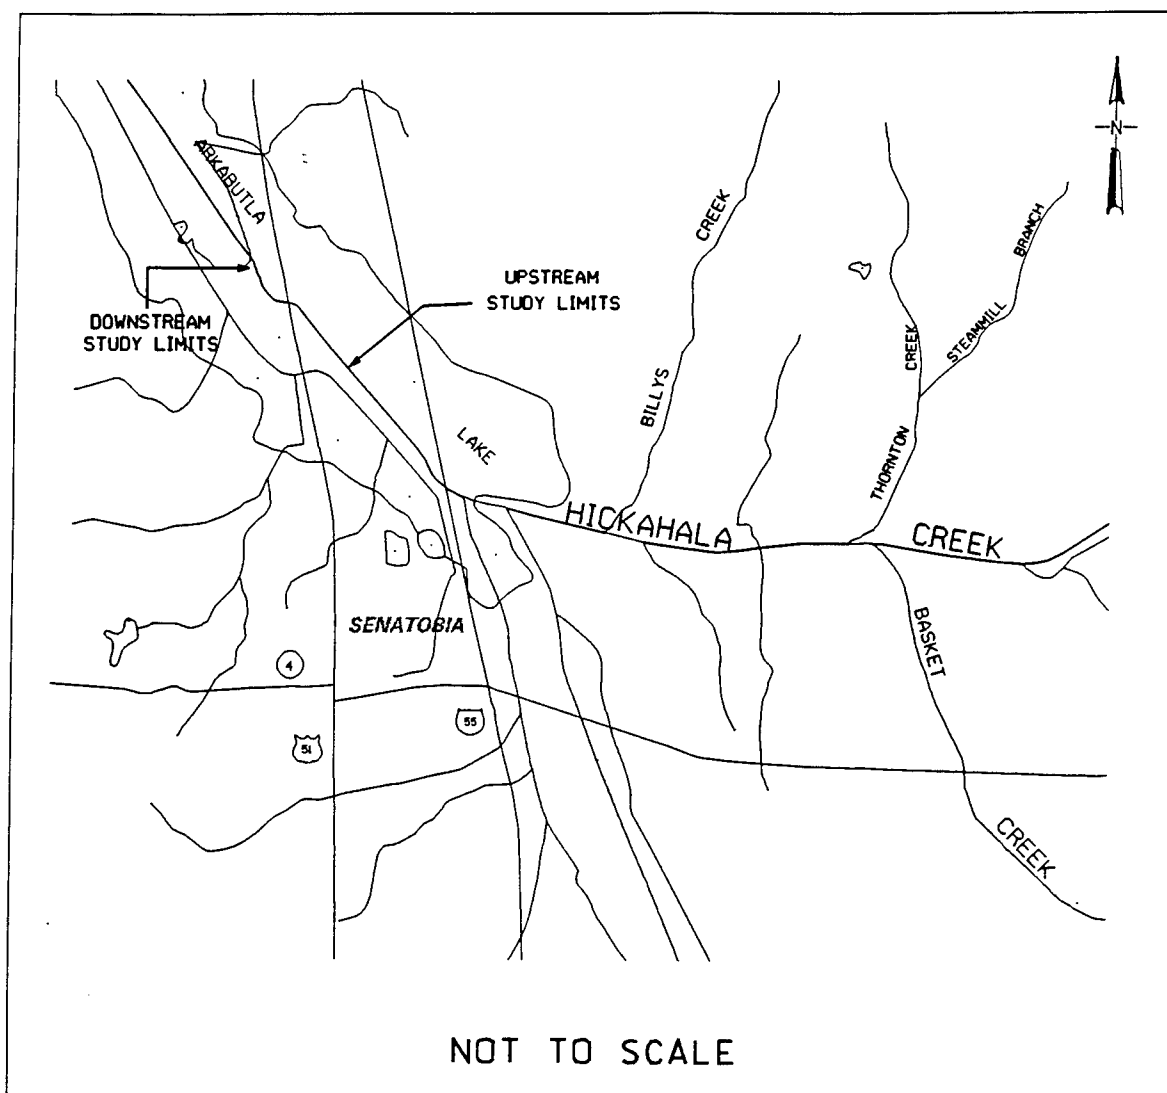
Figure 21. Hickahala Creek, Site 22

Site 22 (Figure 21) is located at the mouth of Hickahala Creek near Senatobia, MS. The present channel is severely choked by debris and a logjam. Channelization of the reach to relieve flooding is planned.

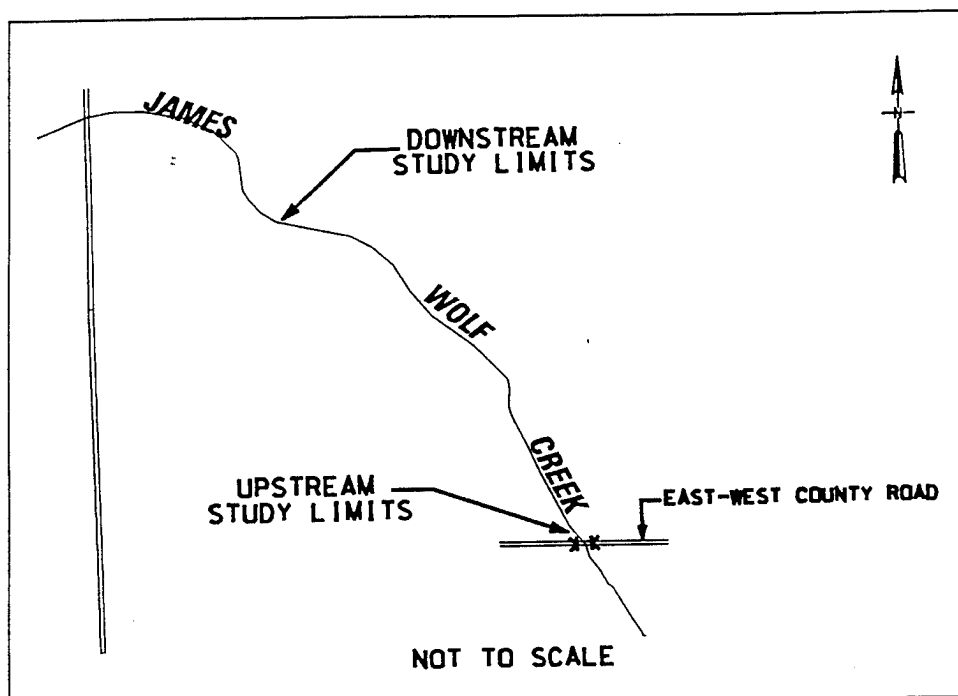
Figure 22. James Wolf Creek, Site 19

- Site 19 is located in the Hickahala Creek watershed on James Wolf Creek. At this location, James Wolf has a drainage area of approximately 11 square miles; however, it is extremely deep and wide. The site is located on the Tyro quadrangle map in T5S, R5W, Section 28. The study reach, shown in Figure 22, extends downstream of the east-west county road for a distance of approximately 4,000 ft encompassing a low-drop structure. This low-drop

structure appears to be stabilizing the bed of the stream; however, the banks remain unstable due to the significant depth. The stream is sand bed, and at low-flow conditions, the channel may be nearly dry. The drop structure on James Wolf Creek monitoring reach has required significant repair since construction and is presently in need of additional repair. Two additional drop structures were constructed on James Wolf Creek downstream of the monitoring reach during 1993.

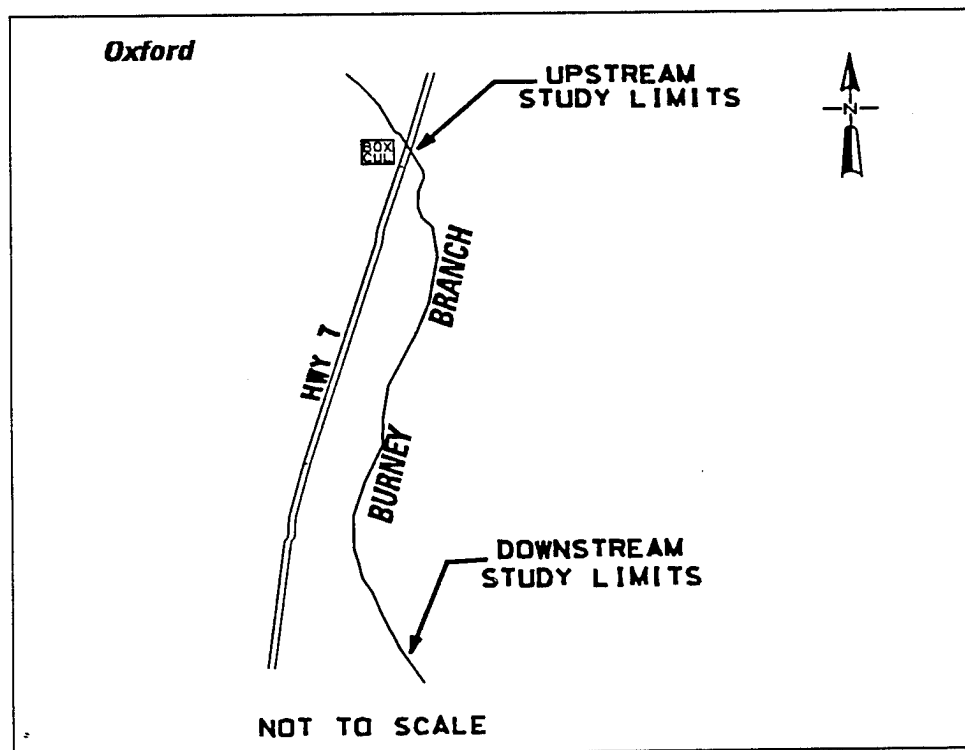
Figure 23. Burney Branch, Site 12

Site 12 (Figure 23) is located on Burney Branch near Oxford, MS. The study reach begins at the Highway 7 crossing of Burney Branch and extends downstream for a distance of approximately one mile through a reach containing two SCS high-drop structures. The drainage area of Burney Branch at this

The two high-drop structures have been very successful in rehabilitating this reach of Burney Branch. Both structures were constructed in 1982 by SCS, and the effects of the structures on the channel were surveyed and analyzed by Schumm, Harvey, and Watson (1984). These structures were designed to contain the 100-year discharge and include the provision for floodplain storage using valley dams in conjunction with each structure. The original design of the structures provided for a bed slope of 0.0008 between structures, based on Lane's tractive stress analysis. The 1984 surveyed bed slope was 0.0012, indicating that the upstream sediment yield was greater than planned. Since 1984, several major channel stabilization projects have been constructed upstream. The survey made in January 1992 will document the effects of changes since 1984 and will provide data with which to evaluate channel change as sediment supply is reduced. Channel stabilization under conditions of reducing sediment supply is a situation that will be faced as the success of the DEC programs is realized. Potentially, upstream stabilization can cause stability problems downstream.
